# **Collaborative 3d Monitoring for Coastal Survey: Conclusive Tests and First Feedbacks Using the SELPhCoAST Workflow**

Abstract: "Structure from Motion" by smart devices photography (SfM-S) is a current promising tool to support 3D participatory monitoring of heritage and geosites. Within the ODySéYeu scientific project, which aims to analyze the sedimentary dynamics around the isle of Yeu (France), a consortium of different local actors was invited to collectively develop an integrated solution to monitor the coastal evolution of the isle in 3D. This new solution is composed of a combination of an application (SENTINELLES de la côte) and a specific workflow (SELPhCoAST), which guides citizens to acquire reliable in-situ photo datasets with their own smart device, facilitates data transmission, and allows both a reliable data treatment and a public presentation of matters and results. This study presents the results of reproducibility and accuracy tests performed on a test-site to validate the SELPhCoAST workflow, over 20 months of monitoring, with multiple operators and devices. Tests show that at least 95% of each SfM-S model is identical to the terrestrial laser scans models

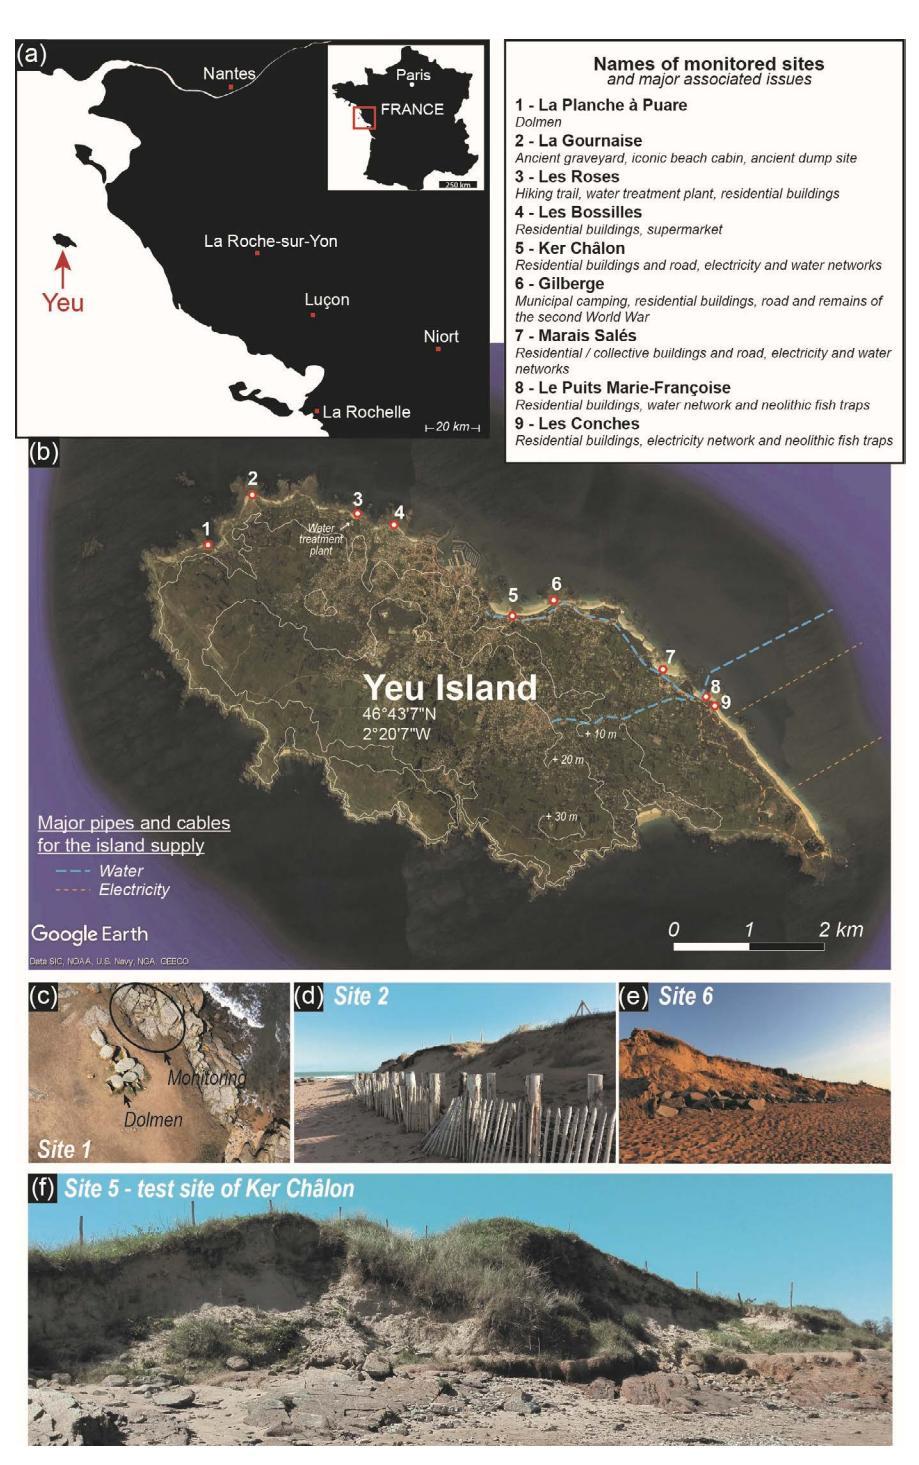
Figure 1. (a–b) Localization of monitored sites and a few examples (c–f).

of the eastern and northern sectors. Along the eastern coast, erosion is becoming more and more preoccupying because of exposed buildings. Some major public infrastructures, facilities and networks are being exposed too. In particular, water and electricity supply pipes and cables land at different places along this coast, and are buried along large portions of this coast, before joining distribution infrastructures (Figure 1).

To experiment the participatory monitoring, nine sites related to major issues (heritage, public networks, buildings, etc.) were chosen along the eastern coast by the ODy-SéYeu consortium. Four sites lay within a classified area, justifying the major constrain of a minimal visual impact of required infrastructures if needed. All sites display at least a few "inert areas", such as outcropping bedrock or sealed reinforced concrete. Site extent never exceeds 100 m for 5 m high. The site of Ker Châlon was chosen here to illustrate tests performed to challenge the SELPhCoAST workflow. This site shows the most complex morphology (two eroded lobs and large screes, generating reverse angles (Figure 1). Its size (30 m wide, 4 m high and 5–11 m deep) enables to challenge the produced morphological reconstructions in the three space dimensions. This site is also a very good example of mixed issues and problematics because it is situated in the middle of a crowded beach. During spring tides, waves reach the cliff base. The outcrop is composed of sand and bedrock at the base, successively overlapped by a palaeosoil of unknown prehistoric age, a sand dune and an old building of the 17th century (probably a building belonging to the first coastal defense system built on the island, according to the municipality heritage service). Finally, the positive relief of the site directly protects from the sea a recent building, parking and the main water supply pipe, all situated less than 50 m backwards. A dozen of habitations are also concerned within a radius of 100 m.

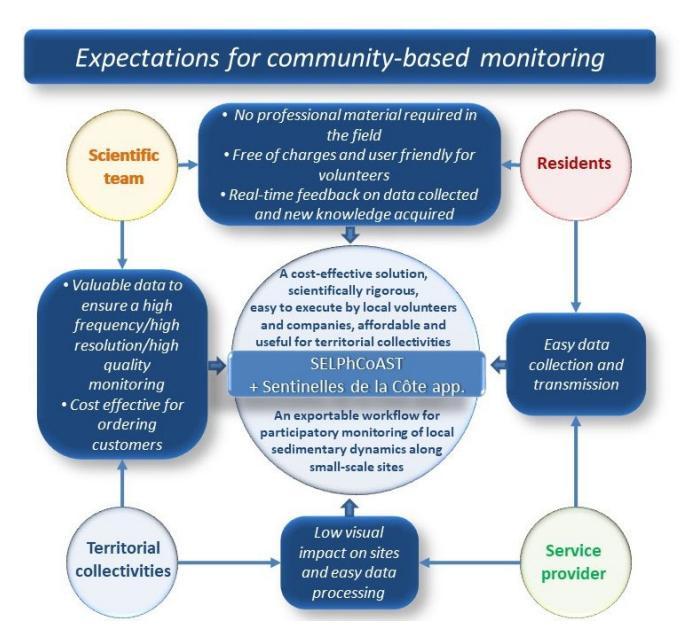
**Figure 2.** Map of requirements for a 3D participatory monitoring tool, as established by the ODy-SéYeu consortium.

Expectations of the different actors were listed (Figure 2) and the two partner companies DIGISCAN3D (specialist in 3D measurement for industry and cultural heritage, 4 rue des Tuiliers, ZA de Viais, 44860 Pont-Saint-Martin, France) and Studio MATAVAI (specialist in web application development, 24 rue Georges Clémenceau, 85350 île d'Yeu, France) were challenged to develop and set up respectively:

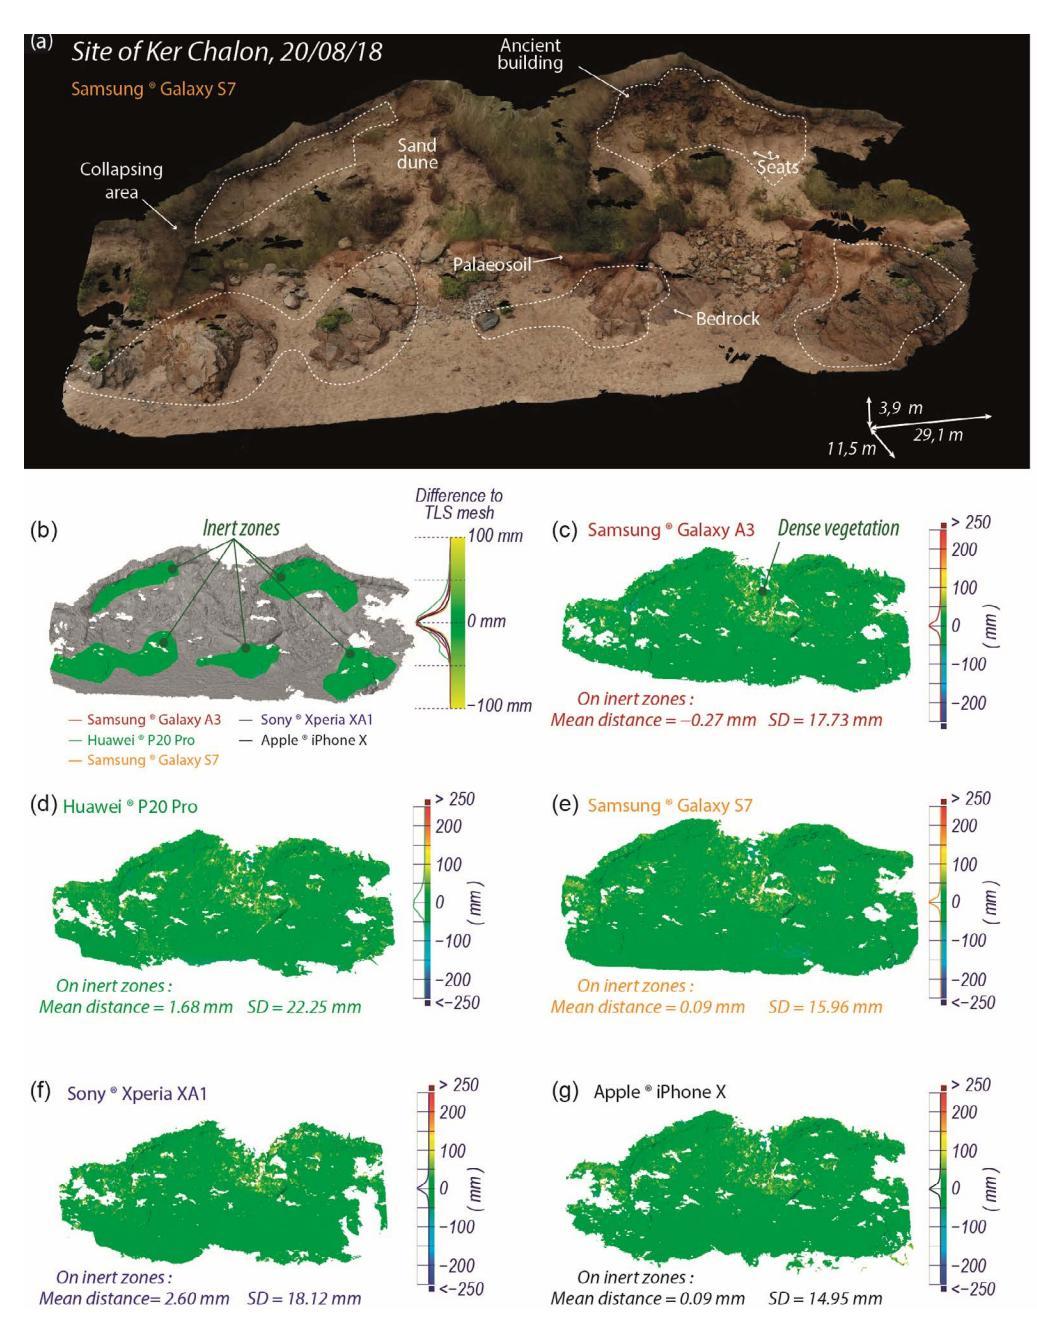
**Figure 3.** First participatory test, 20 August 2018. (a) Textured "Structure from Motion" by Smart devices photography (SfM-S) mesh obtained with a Samsung Galaxy S7 and different points of interest, which will be indicated and documented on public models in Sketchfab®. (b) Position of inert zones considered to compare SfM-S and TLS models reconstructed on 20 August 2018. On the right side of the model, the histograms of distances between inert parts of SfM-S models and identical patches on the reference TLS model were plotted against the colored scale bar. Corresponding values of mean distance to the reference and standard deviation are given for each model in sketches 3 to 7. (**c**-**g**) For each smartphone model: spatial distribution of the difference between the SfM-S mesh and the reference TLS mesh. On the right side of each model, the histogram of distances between entire models was plotted against the colored scale bar.

The first test compares the TLS model performed on 20 August 2018 to the five 3D reconstructions of the site produced using smartphones photographs, on the same day (Figure 3).

All datasets led to the reconstruction of a point cloud (Table 2). On sandy and rocky parts considered as inert during the test (Figure 3a,b), more than 70% of the surface captured by the TLS was also reconstructed in each SfM-S model, highlighting high rates of reconstruction with the workflow, independently of the smartphone model used or the operator.

Figure 3b–g presents surface comparisons between the reference TLS model and each SfM-S model. Along inert zones chosen for the test (Figure 3b), the mean distance between the TLS model and SfM-S models ranged from 2.60 to -0.27 mm (Figure 3c–g), and all smartphones present very similar normal patterns of distribution of distances to the reference, along inert zones (Figure 3b), except the Huawei P20 Pro, which shows a slightly wider distribution. Standard deviations calculated on these areas ranged from 14.95 to

22.25 mm, depending on the model (Figure 3c–g). According to those values, more than 99.7% of points (3SD) were within the tolerance range of ±50 mm for models Samsung® Galaxy S7 and Apple ® iPhone X and more than 95% of points (2SD) were in the tolerance range for the three other models. Along entire models (Figure 3c–g), histograms of differences between the reference model and SfM-S model show that the ±50 mm tolerance range was also respected on entire models, except in areas covered by dense vegetation, which of course were moved by the wind between TLS and photo acquisitions, and appeared randomly in red, blue or yellow on plots. Like on inert parts, the Huawei P20 Pro showed a slightly wider distribution of distances to the reference than other smartphone models on the entire model, but remained within the tolerance range at 95%.

The meticulous observation of the model in Figure 3f showed that the highest differences between the TLS model and the SfM-S model obtained with the Sony® Xperia XA1 were concentrated in parts of the site situated in the shadows. Then, comparing the resolution of photographs provided by the device at the end of the test  $(3840 \times 2160 = 8 \text{ MPx})$  and the native resolution of its camera (23 Mpx), revealed the action of an "aggressive" preprocess, that reworked pixels to lower the size of native pictures before recording them on the phone. This autodegradation of data seems to affect particularly dark areas. The situation is rather similar for the Huawei ® P20 Pro, which is equipped with a complex system of three camera sensors combined to an artificial intelligence (AI), which preprocesses photographic data to "embellish" produced photos. The AI automatically rearranges pixels (pixel binning) and this intervention seems to disturb SfM-S surface reconstruction. For those two smartphone models, disturbances generated by IAs are finally minor but they increase mean distances to the reference and standard deviation and make the 3 × SD value higher than the symbolic preset "±50 mm" value (Figure 3). When the Huawei ® P20 Pro was used to monitor the morphological evolution of the site (on 29 November 2019 and 3 February 2020), the IA was manually inactivated before photo acquisition (for the case of 07/03/20, see discussion below). Thus, SD calculated on inert parts significantly decreased (respectively 12.89 mm and 13.75 mm), making the models perfectly acceptable and demonstrating the responsibility of the IA in degrading native datasets. This point is very important for a participatory perspective, because if these kinds of photo preprocessing tend to generalize to all smartphones in the future, it could hinder the use of SfM-S. At least, smartphones using such IAs should be identified/listed. Hence, to be user-friendly, applications guiding participatory photo acquisition for SELPhCOAST should include the automatic inactivation of any IAs and resizing preprocessing, because modifying photo acquisition parameters of its own smartphone is not trivial to all users.

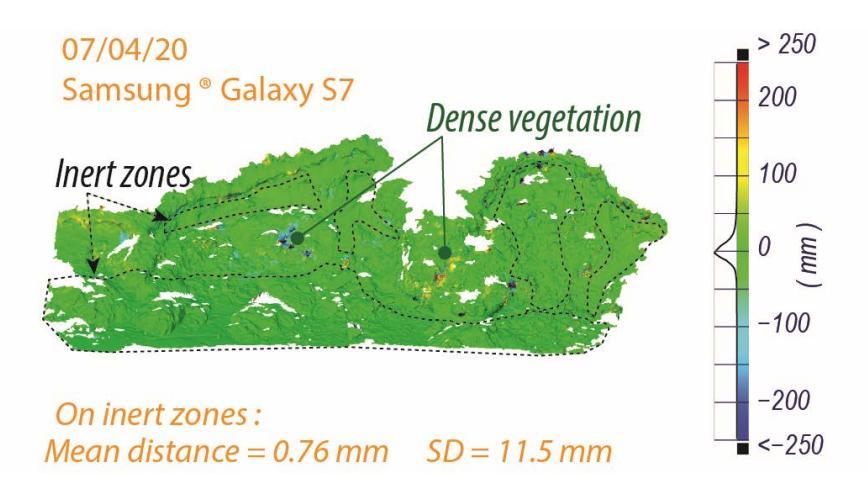
**Figure 4.** Spatial distribution of distances between the last SfM-S model and the simultaneous final TLS acquisition of 7 April 2020. On inert parts of models, the standard deviation significantly decreased with regards to results obtained with the same smartphone model in 2018 (previous figure). For a rather similar SfM-S model reconstructed, the required number of photographs droped from 54 to 33, and data acquisition was lower than 5 minutes, showing that after 20 months of semiparticipatory monitoring experience on the site, the improvements made in SELPhCoAST induced a significant gain in both accuracy and operability.

After revision of the workflow (Test 4), comparison of the two TLS and SfM-S models performed on 7<sup>th</sup> April 2020 shows a mean distance between reference and SfM-S model of 0.76 mm and a standard deviation of 11.5 mm over the whole inert parts (sand + bed-rock) selected (Figure 4). Over the same areas, the percentage of surface reconstructed on the SfM-S model by comparison to the surface captured by the TLS reach 86.8%.

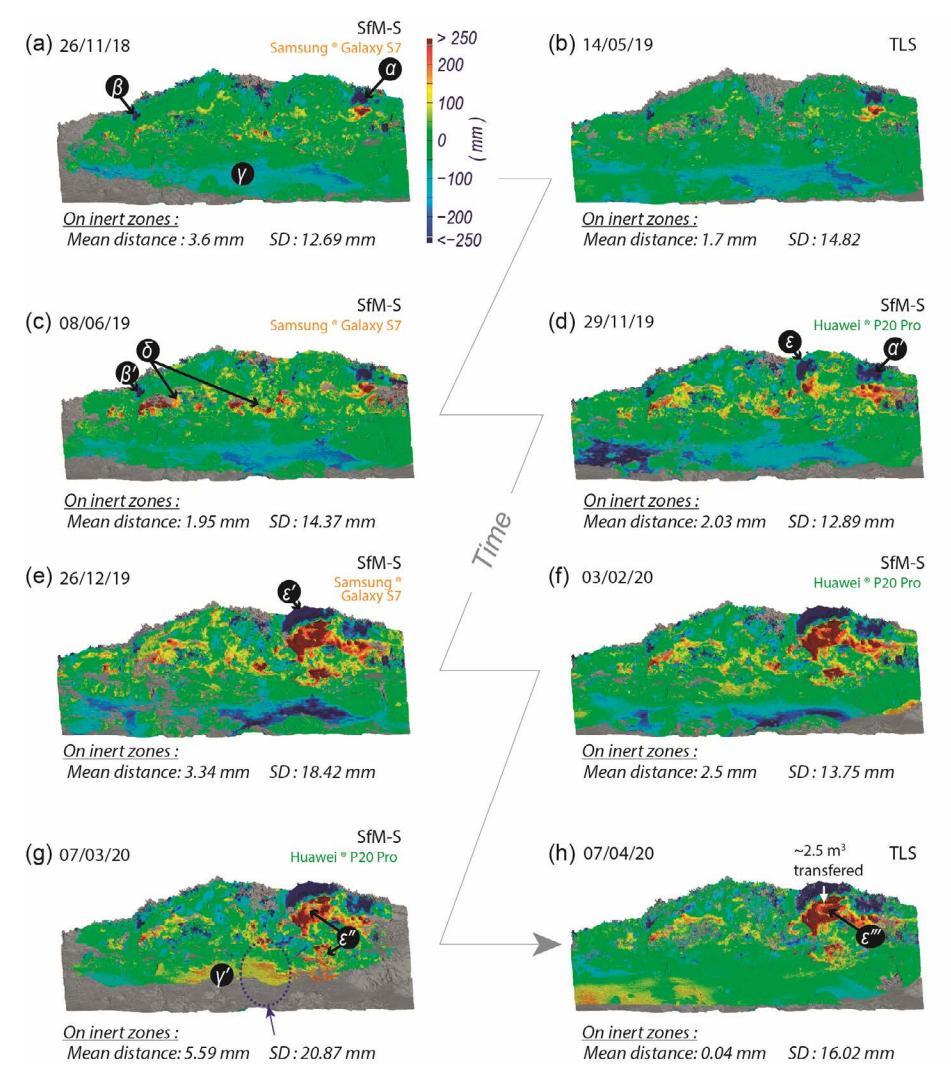
**Figure 5.** (**a**–**h**) sketches represent the reference TLS mesh of 20 August 2018 on which displayed colors indicate the local difference (distance, in mm) between the reference mesh, and the new 3D model reconstructed after each survey (SfM-S or TLS), over the 20 months monitoring. The scale bar presented in (**a**) is common to all sketches. White Greek letters are mentioned in the text, and refer to events represented on the timescale in Figure 6.

Computation of the comparison between the reference TLS model (20<sup>th</sup> August 2018) and the eight successive models acquired both by SfM-S and TLS over the 20 months survey shows the morphological evolution of the test site (Figure 5). Mean distances to the reference range from 5.6 to 0.04 mm on the inert zones (bedrock only). Standard deviations range from 20.87 to 12.69 mm on the same zones. On the contrary, huge differences were locally recorded on "mobile areas" (sandy or vegetated), showing a differential evolution of the morphology. Maximum erosion was recorded in the upper right corner of the four last models (deep blue areas repaired by  $\varepsilon'$  on Figure 5e), with values up to -1200 mm. Maximum accretion was recorded just below maximum erosion zones (large deep red area in models 5–8, repaired by  $\varepsilon''$  and  $\varepsilon'''$  in Figure 5g–h), with maximum values up to

+350 mm. This erosion/accretion vertical couple typically highlights a collapse of material. According to GOM Inspect Pro software, the collapsed volume in this sector is estimated to be about 2.5 m<sup>3</sup>. Other erosion/accretion zones were also recorded along the rest of the sand cliff but were not comparable in extension or volume. Sand dynamics of the upper beach was perfectly visible (examples repaired by  $\gamma$  and  $\gamma'$  on Figure 5a,g), showing sand moving back forth, with creation of ephemeral depressions (up to 300 mm deep) and bumps (up to 170 mm high).

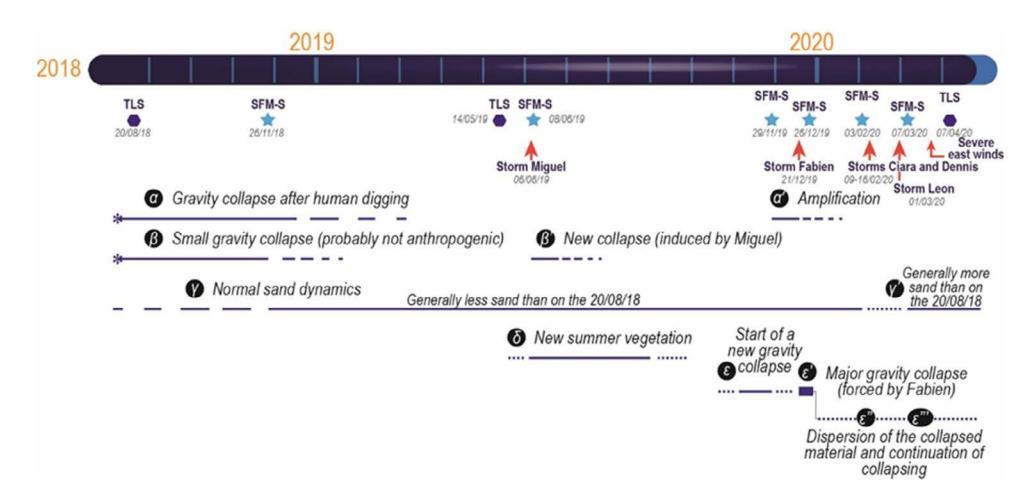
Figure 6. Timeline reconstructed combining field observations, reconstructed models and major meteorological events.

The additional confrontation of the schedule of local storms and the evolution of the morphology of the site revealed that storms are clearly involved in the massive collapse mechanism, but waves are not the major erosion source. Indeed, major storms are generally associated to major erosion pulses but erosion is generally recorded in the upper part of the site, never reached by waves, suggesting that on this site, wind, precipitations and soil water content were more involved than wave action in the erosion over this survey of 20 months. The fact that only minor gravity collapses occurred during the late spring storm Miguel supports this assumption because the climax of the storm occurred at low tide, with a tide coefficient of 85. Thus minor collapses were probably only reactivated by associated precipitations. On 22 December 2019, the storm Fabien was responsible of major collapses but the storm is associated to a small tide coefficient of 61, and precipitations are most probably responsible of the collapse since waves did not reach the site. Storms Ciara and Denis occurred during February spring tide but they seem more associated to dispersion of the material previously collapsed than to a major new collapsing event.
